BARWON HEADS BRIDGE

REPORT OF THE ADVISORY COMMITTEE

JANUARY 2007

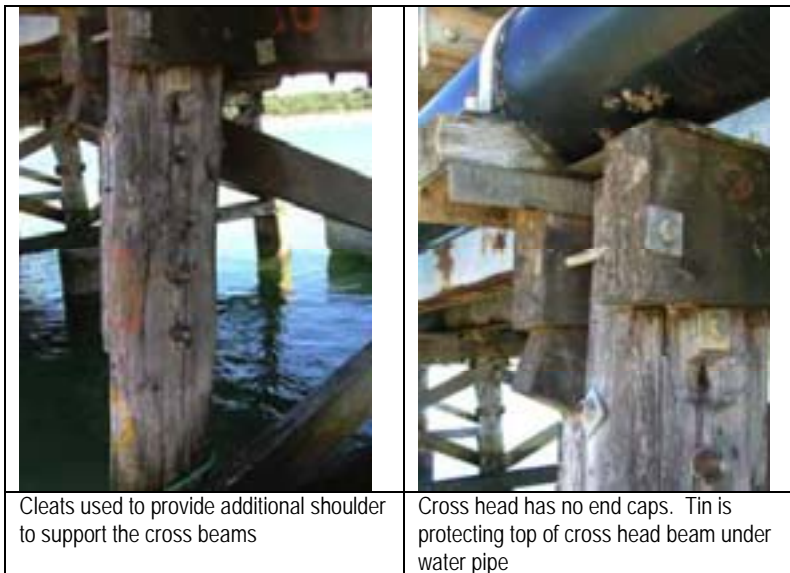
Photograph 2: Condition of crossheads

Glynn Jones (2006) concluded that the crossheads are generally in fair condition except on the downstream side where continual wetting from runoff from the large water main has caused rusting and swelling of the crosshead bolts resulting in vertical splitting of many crossheads. Some crossheads show minor deterioration under the steel beam stringers.

The crossheads should sit on rebates in the pile tops, but this is not always the case. For Michael Verey the crosshead to pile connections are the most concerning feature of the bridge. The crossheads do not sit properly on the piles because of the poor condition of the tops of piles, inadequate seating of crossheads and the condition of crosshead ends.

The current condition of the connection of the crossheads to the piles is poor. The seating of the crossheads on the piles need to be repaired, remediated or strengthened.

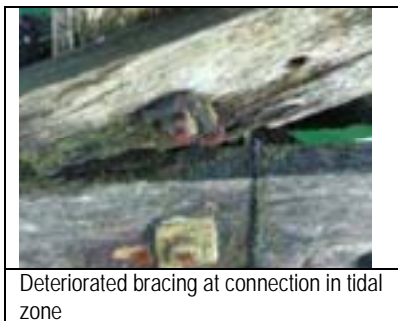
Photograph 3: Condition of bracing

Glynn Jones (2006) assessed the pier bracings as ranging from just satisfactory to good in condition.

Cross braces and lower waler members were found to have adequate structural strength when considering vertical loads on the Bridge. It is noted that cross braces and walers serve an important role in resisting the effects of horizontal loading such as flood, wind loading and vessel impact and these were not assessed in the theoretical analysis.

The current condition of the bracing and walers is satisfactory to good.

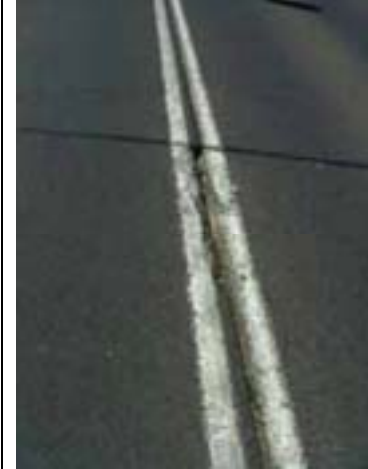
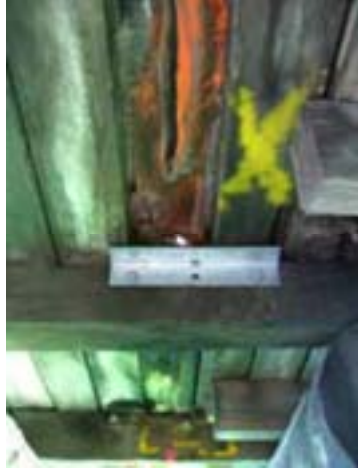
Photograph 4: Condition of stringers, corbels and cross frames

The wooden stringers have deteriorated and most (or perhaps all) have been removed. The wooden stringers have not served a structural function since the steel stringers were introduced.

The steel stringers are still structurally sound, although the surface coating has deteriorated. All steel stringers could be cleaned and painted to lengthen their life.

The support for these beams is provided by timber packers which are subject to long term deterioration and crushing which could seriously reduce their capacity.

The effects of corrosion, on both the effective section and possible fatigue cracking, need to be considered, particularly around welds. The weld quality, with respect to fatigue details, is variable according to Mr Steven's (limited) observations with some in the poor category.

The current condition of the steel stringers and cross frames is generally good.

Crushing of bearing pads under steel beams	Typical rot of corbels beneath drainage points	No bracing between central corbels

Heavy oxidation on bracing due to salt splash	Total collapse of beam above corbell

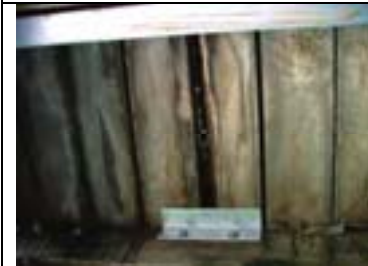
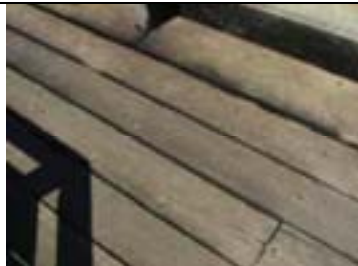
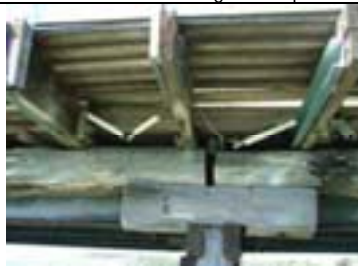
Photograph 5: Condition of the deck

Deterioration has occurred in the cross beams along the Bridge centreline due to the ingress of water through the longitudinal joint in the concrete overlay. This has resulted in the collapse of a few crossbeams and resultant loss of support for the longitudinal timber deck planks which are, in turn, supporting the concrete overlay. This exacerbates the tendency for cracking in the overlay. More crossbeams will collapse in the short term as water continues to permeate the deck cracks.

As the timbers supporting the concrete overlay rot or soften, they fail to provide support to the concrete overlay which results in cracking. The risk of sudden failure is small, particularly if the current load limit is observed. However, the risk of deck cracking is a reality as cracking is currently occurring.

The current condition of the deck timbers is poor. The deck needs significant repair or replacement.

<p>Cracking of bituminous deck and hole in central section of the bridge</p>	<p>Timber rot and deterioration as a result of moisture collection. Source of moisture is from an above deck hole.</p>	<p>Central deck planks earmarked for replacement. New angle brackets are proposed to re-establish support under deteriorated ends of longitudinal planks.</p>

<p>Steel brackets connected to timber crossbeams used to support ends of timber decking that has significant rot.</p>	<p>Fire damage under walkway has not been repaired</p>	<p>Unprotected lighting conduit and cabling</p>
